Performance Measurement Report

Performance Measurements
for the West Bay Sanitary
District Using the “Effective
Utility Management”
Framework

Includes Data and Analysis for
Calendar Year 2019

WEST BAY
SANITARY DISTRICT

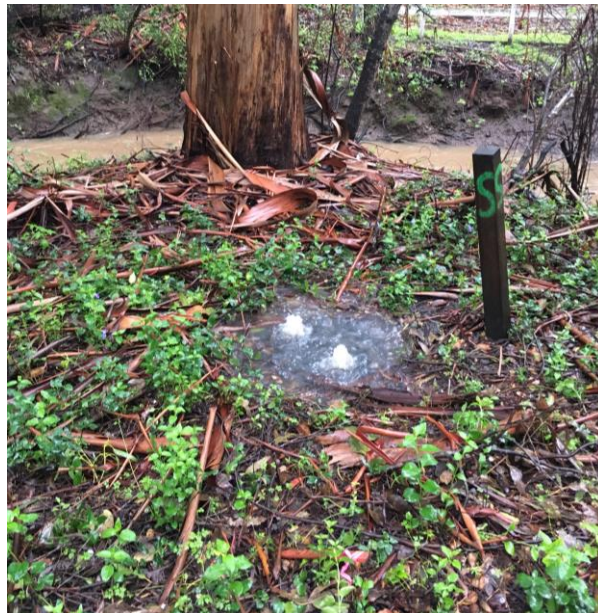
Sanitary Sewer Overflow (SSOs) 2012 to 2019

The District’s goal is to maintain the sewer collection system so that there are no SSOs. Especially important is to prevent overflows that reach a creek, tributary-drainage channel or other body of water, all of which are considered “Category 1 SSOs”. While the overall goal is to prevent all overflows, the interim goal of the District is to have fewer overflows within Region-2 of the San Francisco Bay Area. Region-2 has approximately 115 participating Agencies and that data is more reflective of West Bay Sanitary Districts Age, terrain and geological characteristics.

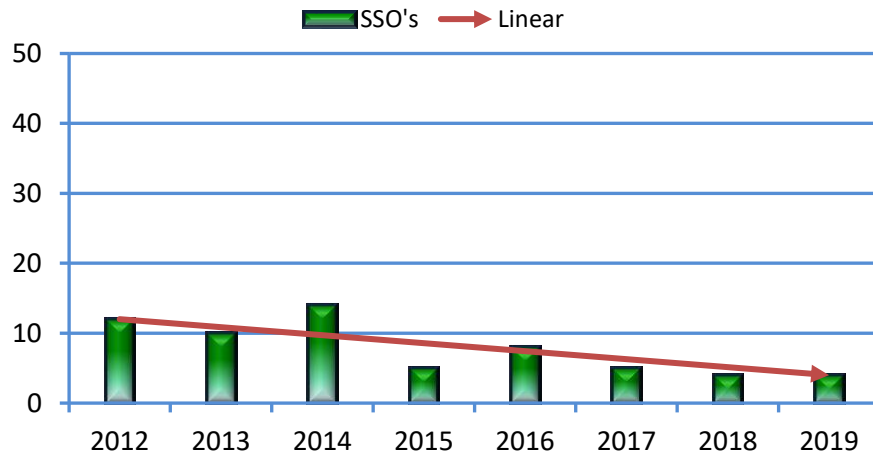
Analysis: Over the last nine years the District has implemented a rigorous maintenance program to reduce and prevent future SSO's. The implementation of an aggressive cleaning coupled with the Root Foaming Program in 2010, has resulted in a reduction from 55-SSO's in 2008 to 4-SSO's in 2019. This is the fifth consecutive year in the District's history to record single digit numbers.

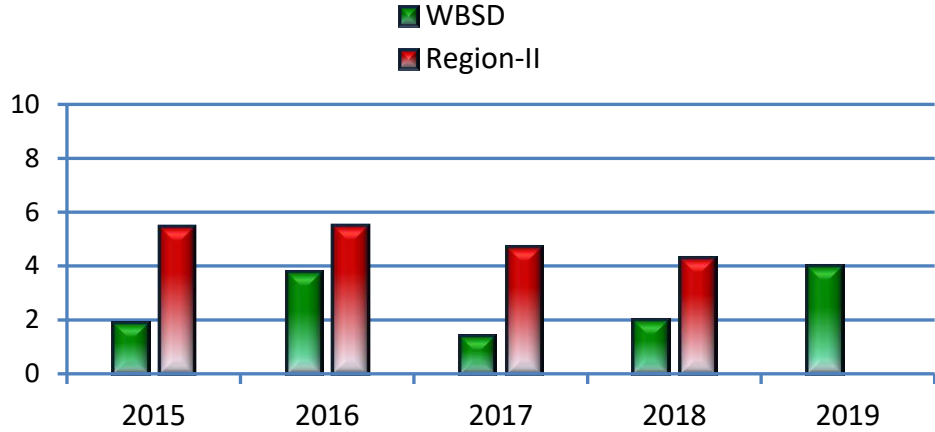
Analysis: In 2019, the District reported 4-spills less than 1,000 gallons. Region II had 591 Category 3 SSO's averaging 3.6 SSO's per 100 miles of Pipe. The District's average for Category 3 SSO's averaged at 2 per 100 miles of Pipe in 2019, significantly less than Region II over the last 5 years. This success is due to the Root Foaming Program and increased maintenance by placing all 4, 6, 8 and 10- inch pipes (considered small) on a 12- month cleaning cycle, as well as using hydraulic root cutter with flexible finishing blades and using proofing skirts on water jet nozzles to ensure a thorough cleaning of each line segment.

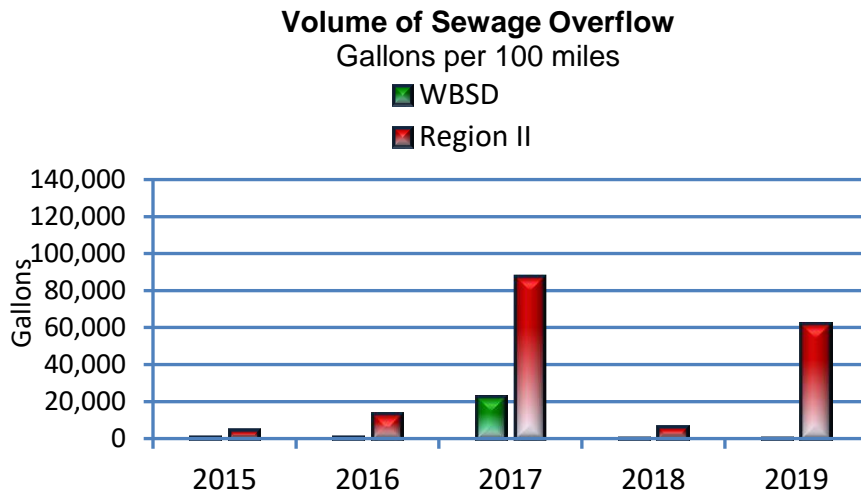
Analysis: The average volume of SSO's in Region 2 for 2019 was 61, 830 gallons per 100 miles of pipe for Category 1, 10,691 gallons per 100 miles for Category 2, and 459 per 100 miles for Category 3. The District's Sewage spill rate in 2019 was 350 gallons per 100 miles of pipe. The District's quick response time, training, keeping lines cleaner, and performing root control both mechanical and chemical, have allowed for lower spill volumes.

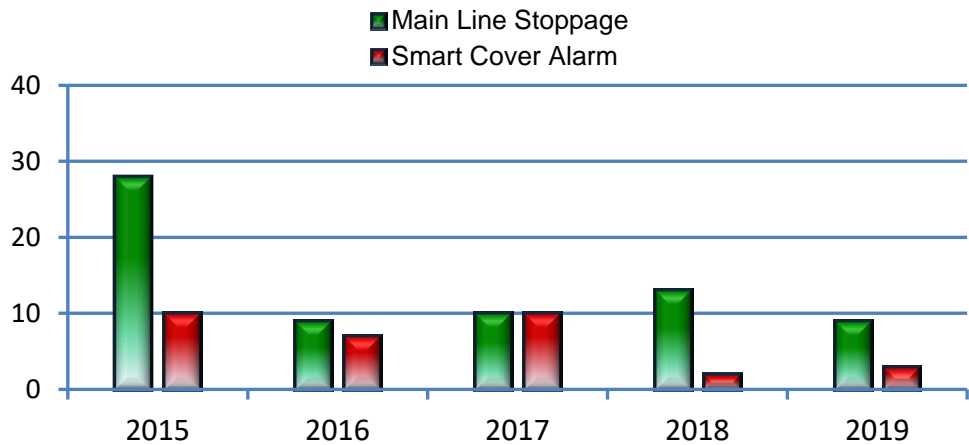
Analysis: The District has made significant improvements in this area and stoppages have dramatically been reduced. A downward trend is indicative of a well-focused maintenance program. 2015 equaled 28 main line stoppages identified by staff during routine maintenance. An additional 10 Smart Cover alarms were installed and several of those prevented potential SSO's in environmentally sensitive areas. In 2018 the District had found 13 sections of mainlines holding prior to performing routine maintenance and 2-smart cover alarms indicating potential problems for a total of 15.

In 2019, the District found 9 main lines holding and were received by 3 Smart Cover Alarms. The Smart Cover alarms not only have prevented an SSO from occurring but have also provided an upward "Level Trend" report allowing staff to respond to potential blockages before they occur.

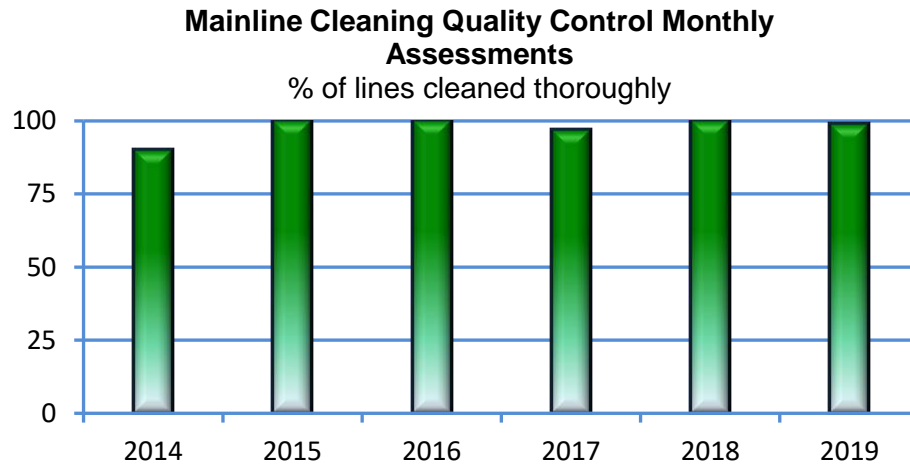
Analysis: In 2011 mainline cleaning quality control and monthly assessments were implemented and reached 85% due to the addition of new nozzles, hydro flusher configurations (hose sizes and nozzle re-jetting) and employee training. In 2012 we achieved an average of 86% lines cleaned thoroughly. In 2013 we increased the amount of line segments which are surveyed for quality control from 4 per month to 5 per month. In 2014 we surveyed a total of 60 line segments, and the percentage cleaned thoroughly was 83%. In 2015 we increased the amount of line segments surveyed for quality control from 5 to 6 per month. We also introduced the use of “proofing skids” on all hydro flush cleaners. Proofing skids are placed between the end of the cleaning hose and the cleaning nozzle to ensure that the roots or grease in the pipe is cleaned, at a minimum, to the diameter of the proofing skid. In 2019 the District had 99% quality control. Proofing skids and hydraulic root saw have been the best contributor to these results, coupled with proper maintenance worker training.

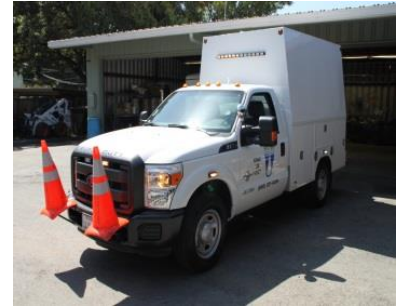
Average Response Time to Mitigate SSOs
(After hours - Minutes)

- SSO Response Time:** In 2008 the State Water Board amended the WDR by requiring a “2-Hour Reporting time frame” on SSO’s impacting a water body. To ensure the District met this requirement, staff members living within a 35 mile radius from the District were allowed to take the District “Response” vehicle home, allowing them to be on sire within 45 minutes, mitigate the SSO, call in addition resources if needed and complete the operation within the 2 hours reporting requirement of the WDR.

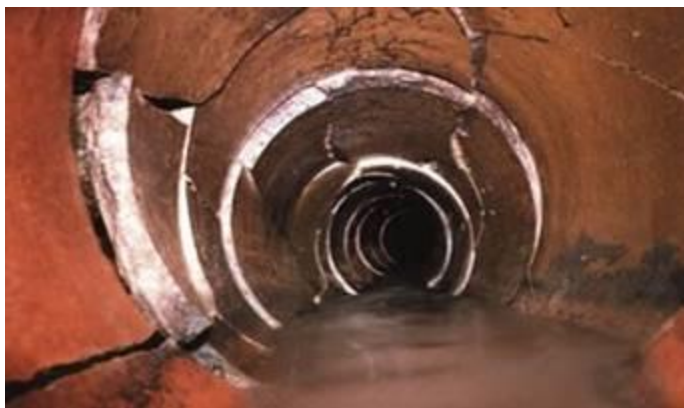
Analysis: The District inventoried all assets in 2010 in preparation for the 2011 Collection System Master Plan. In 2011 we re-assessed by visually inspecting approximately 25% of our assets by CCTV in miles of pipes and manholes. 14 miles were done by an outside contractor in 2011 approximately 23% of our assets were re-assessed. The remainder of the re-assessments were all performed in-house. The annual goal is 20% per year. In 2019 District crews re-assessed 20% of the system.

- **Sewer Main Condition Assessment:** This graph shows the percent of sewer main lines that are video inspected each year and assessed for condition and maintenance problems.

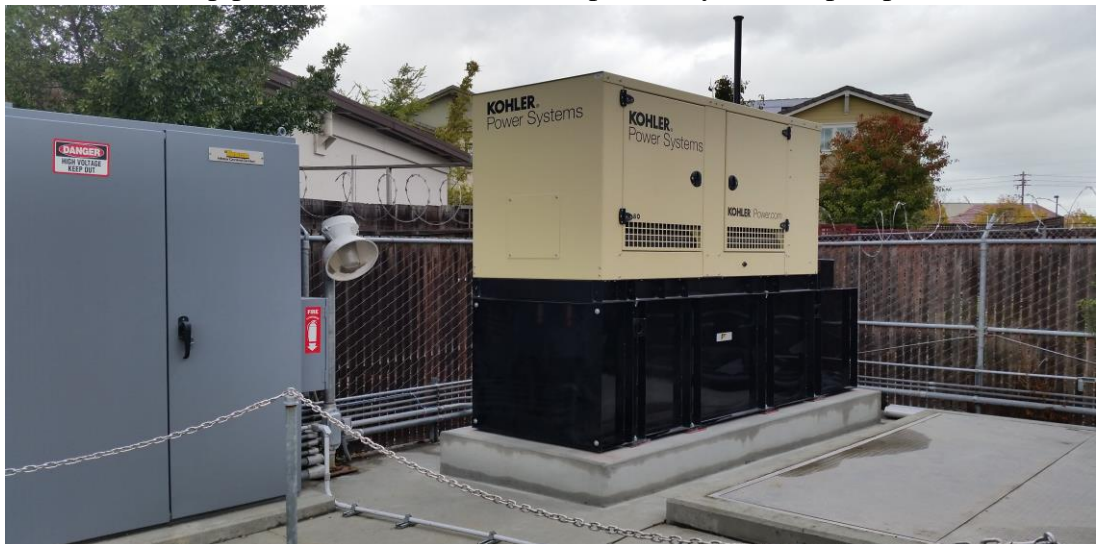
- **Power Resiliency:** This is the number of hours that backup power is available at the pump stations and the “Time to Overflow” if all things failed. Note: Excluding the FERRF, every pump station in the collection system has a backup standby generator and pump bypass capability.

In late 2019, PG&E conducted their “Public Safety Power Outage” which affect there of the publicly owned pump stations. All three had generator back up power and worked well. After about 10 hours of run time. The Sausal Vista Generator failed. It took approximately two hours to have another generator installed. No SSO occurred as a result.
